Fluvial Geomorphology Assessment and Meander Belt Width Delineation

Tributary of Boyne River
Melancthon, Ontario

Submitted:
August 21, 2025

GEO Morphix Project No. 24060

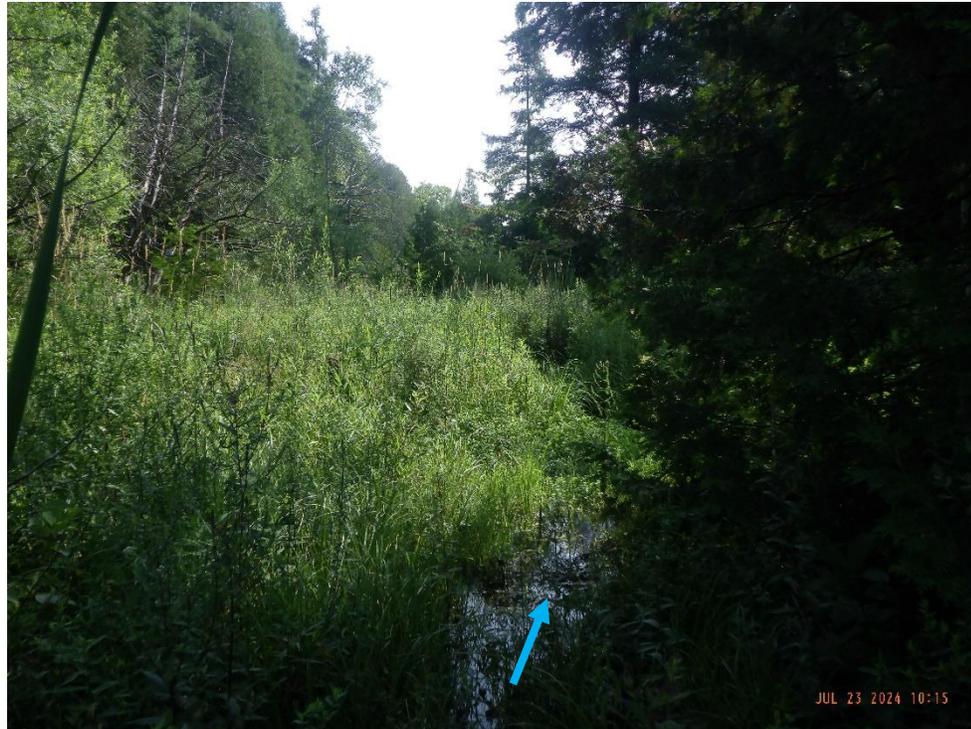
Photo 1
Reach TBR-1, Tributary of Boyne River, Melancthon, Ontario

Photograph taken at the upstream extent of **Reach TBR-1**. A narrow flow path observed through a wetted floodplain/corridor area. Blue arrow denotes flow direction.

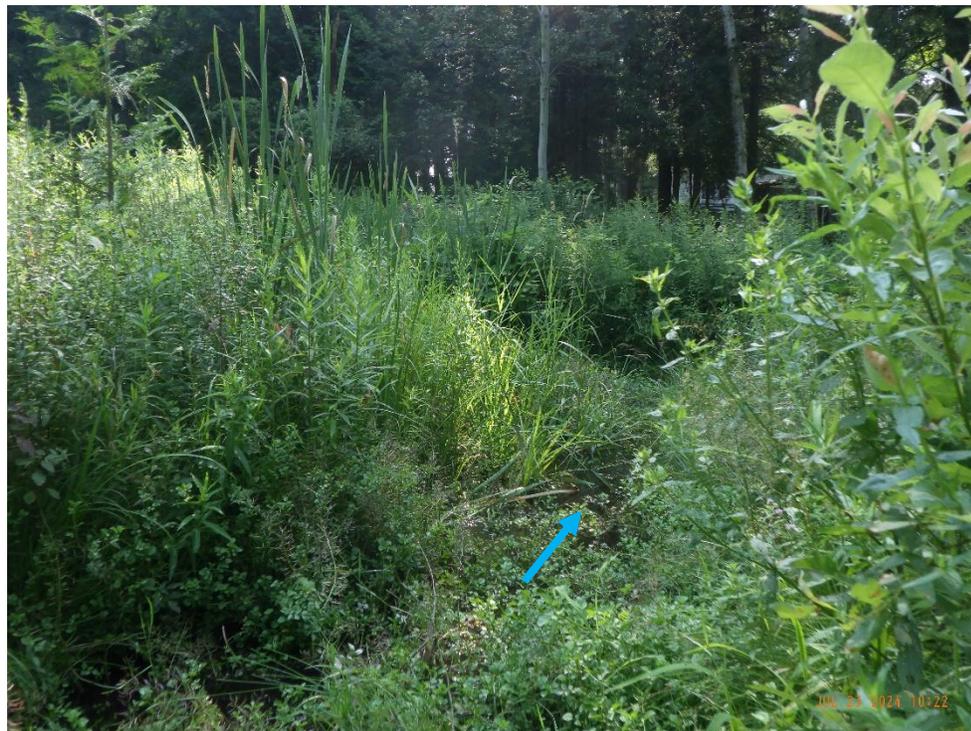
Photo 2
Reach TBR-1, Tributary of Boyne River, Melancthon, Ontario

Riparian vegetation within the wetted corridor consisted of grasses, forbs and shrubs on hummocky, saturated terrain. Cedar forest bordered the corridor on both sides.

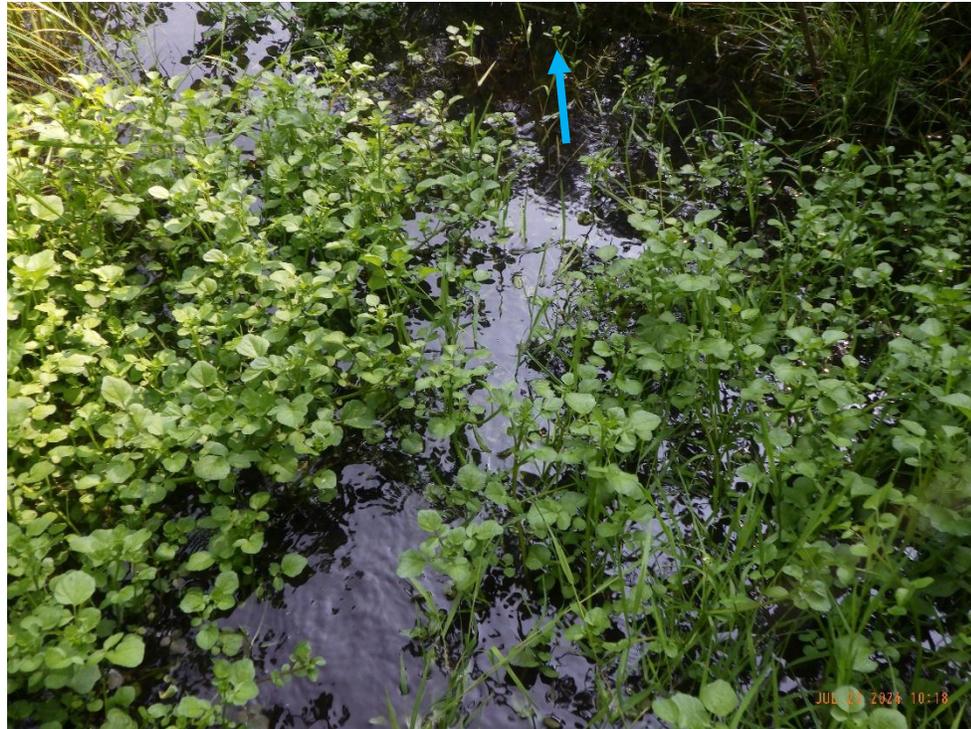
Photo 2

The instream vegetation found was predominantly watercress. It covered about 20% of the reach.

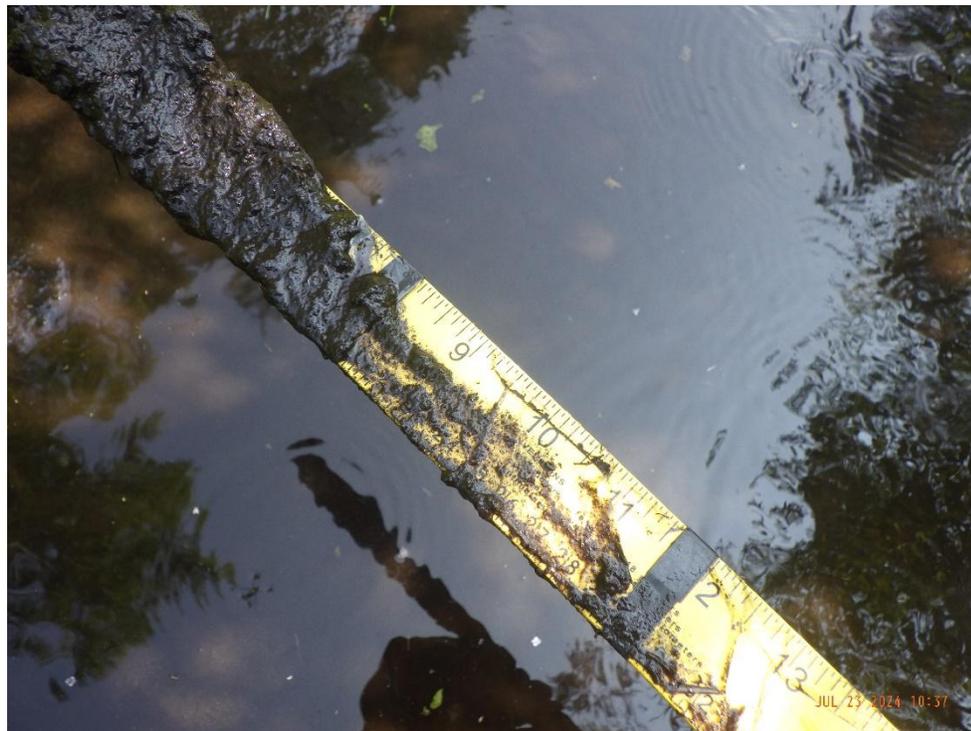
Photo 3

Substrate consisted of a soft/loose loamy soil (organic-rich clay and sand) with rootlets.

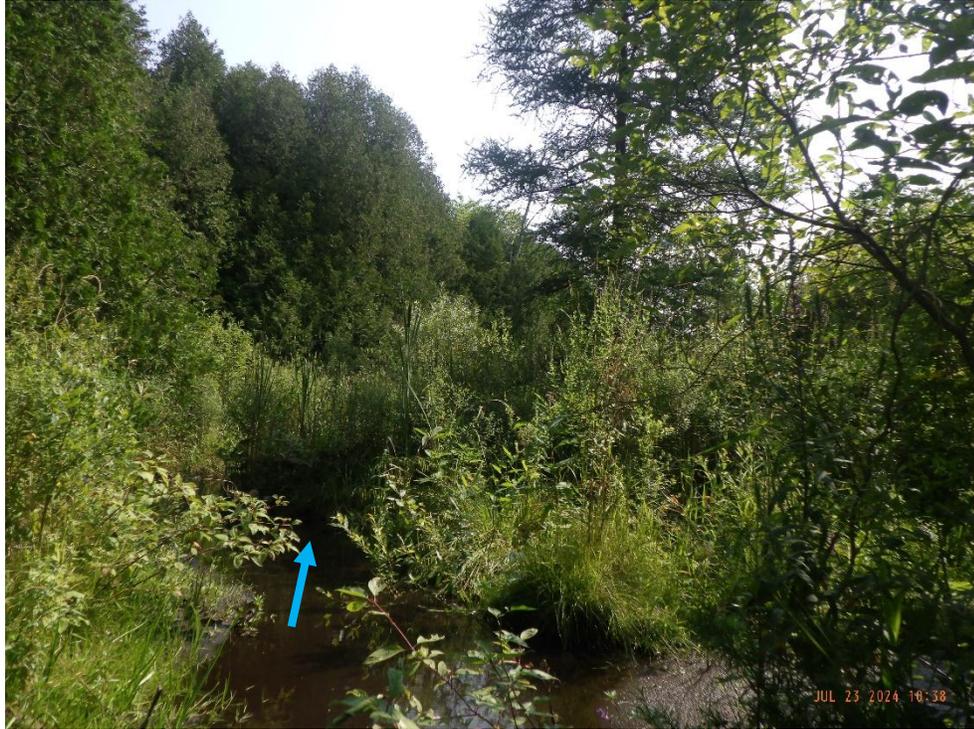
Photo 4
Reach TBR-1, Tributary of Boyne River, Melancthon, Ontario

Photograph taken facing downstream at a meander bend in the flow path. Wetted surface area expands further downstream. The blue arrow denotes flow direction.

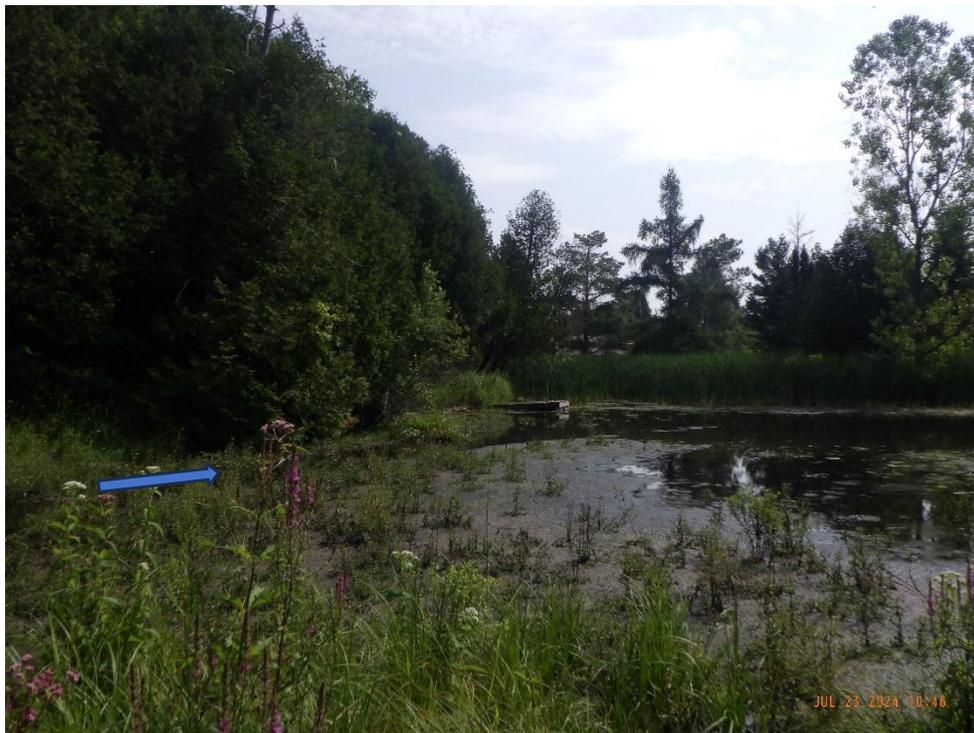
Photo 5
Reach TBR-2, Tributary of Boyne River, Melancthon, Ontario

Photo taken where **Reach TBR-1** enters a pond. This is the upstream extent of **Reach TBR-2**. The blue arrow denotes the direction of flow from the stream into the pond.

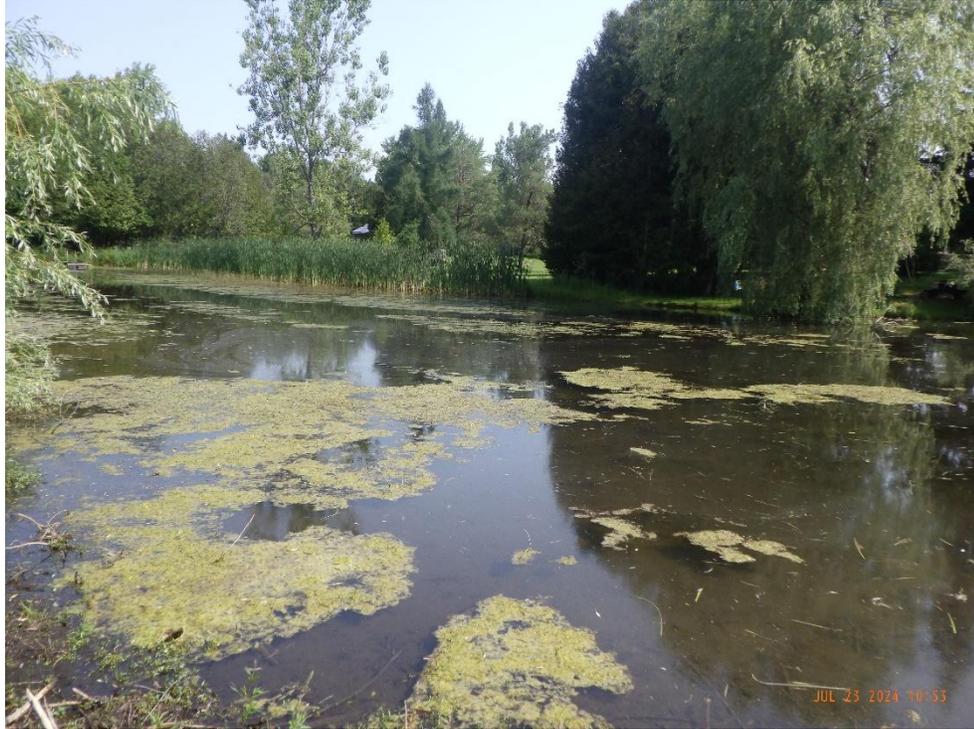
Photo 6
Reach TBR-2, Tributary of Boyne River, Melancthon, Ontario

Photograph taken facing the upstream extent of the pond. Note moderate algae growth is visible. No erosion observed along the edge of the pond.

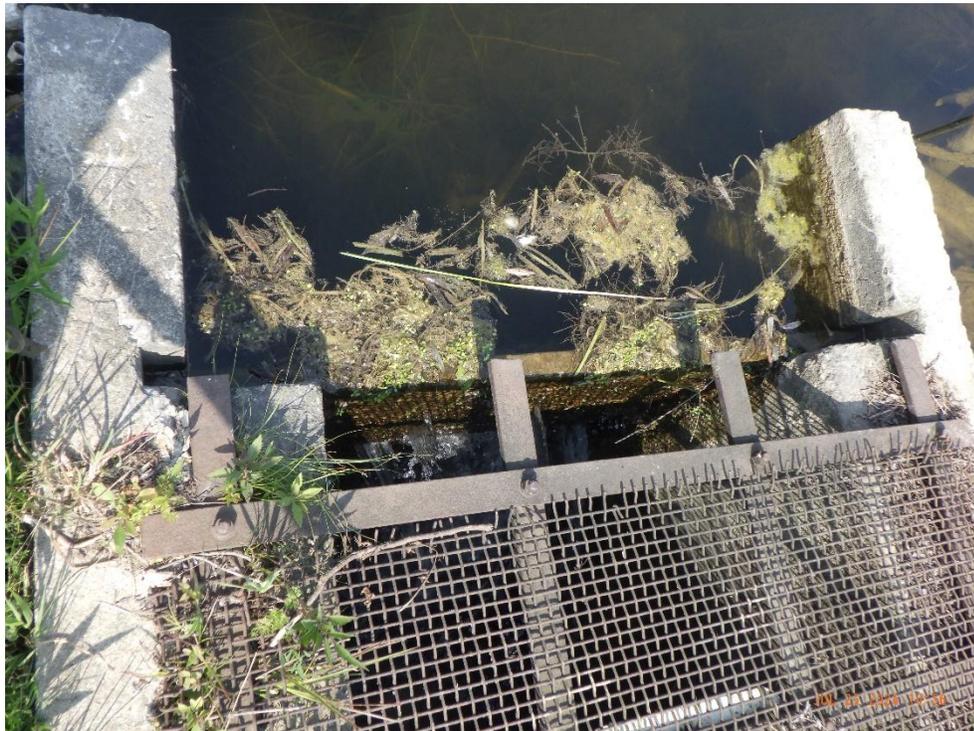
Photo 7
Reach TBR-2, Tributary of Boyne River, Melancthon, Ontario

Photograph taken of the outlet from the pond into the downstream extent of the watercourse/drain.

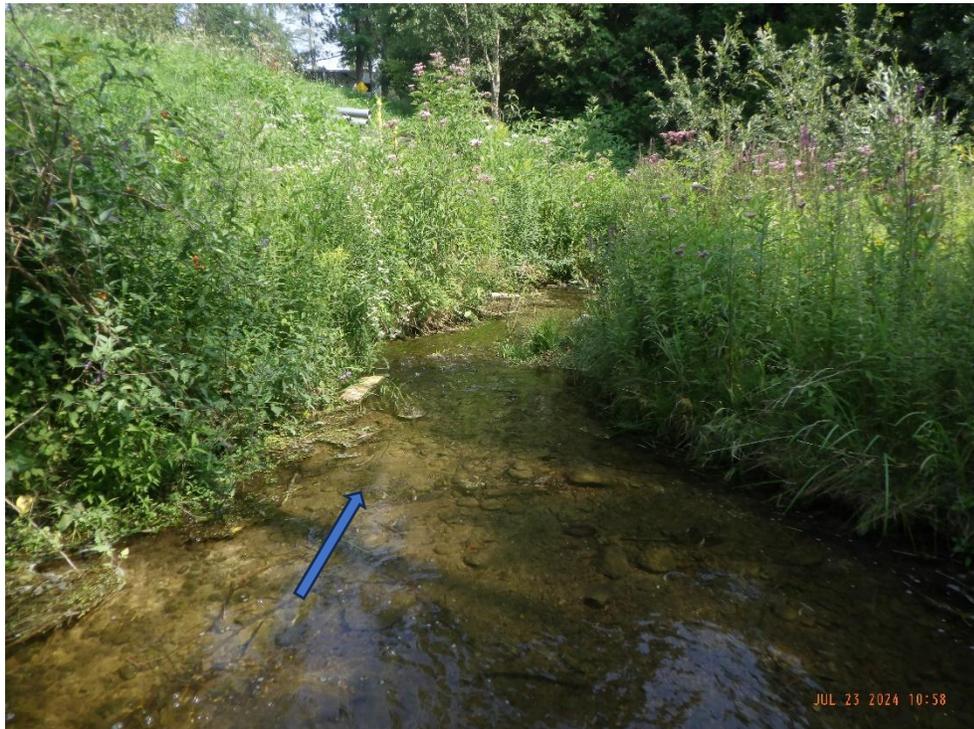
Photo 9

Photograph taken at the upstream extent of **Reach TBR-3**, facing downstream. The substrate ranged from sand to small cobbles.

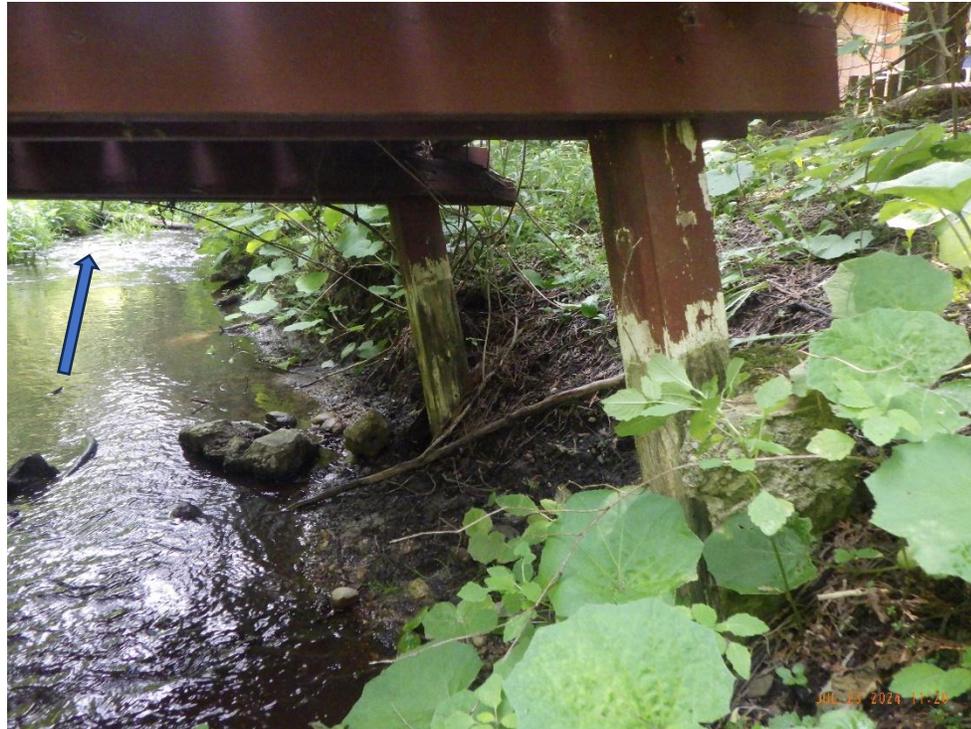
Photo 10
Reach TBR-3, Tributary of Boyne River, Melancthon, Ontario

Reach TBR-3 was assigned an RGA score of 0.203, indicating the reach is in transition, with degradation as the dominant process of adjustment. This is evidenced by exposed bridge footings, elevated storm sewer outfalls, and scour pools downstream of the storm sewer outlets. An RSAT score of 37 was determined, indicating that this reach was in excellent health. The limiting factor for **Reach TBR-3** was a wide forested riparian buffer that is predominantly mature trees. This reach was classified as stable based on Downs (1995) classification and exhibited a straight river style framework.

Photograph taken facing downstream of a constructed bridge across the channel. Note some bank erosion is visible around the exposed bridge footings.

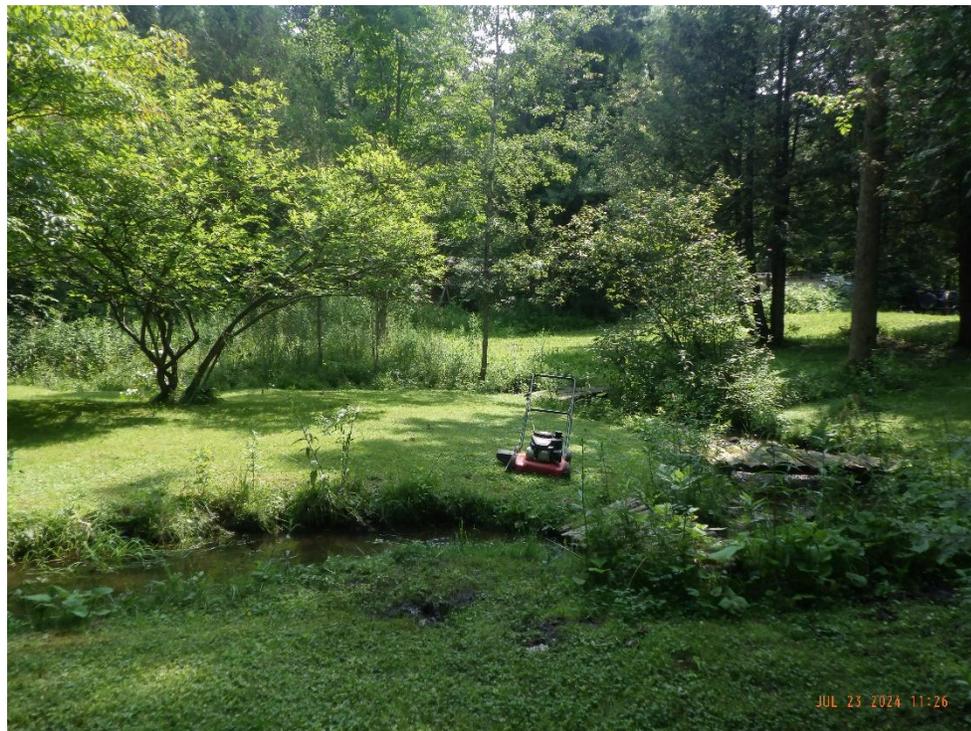
Photo 11
Reach TBR-3, Tributary of Boyne River, Melancthon, Ontario

Photograph taken facing downstream, demonstrating a meander bend. The meander amplitude was 7.98 m. Note the surrounding land use at this extent was residential.

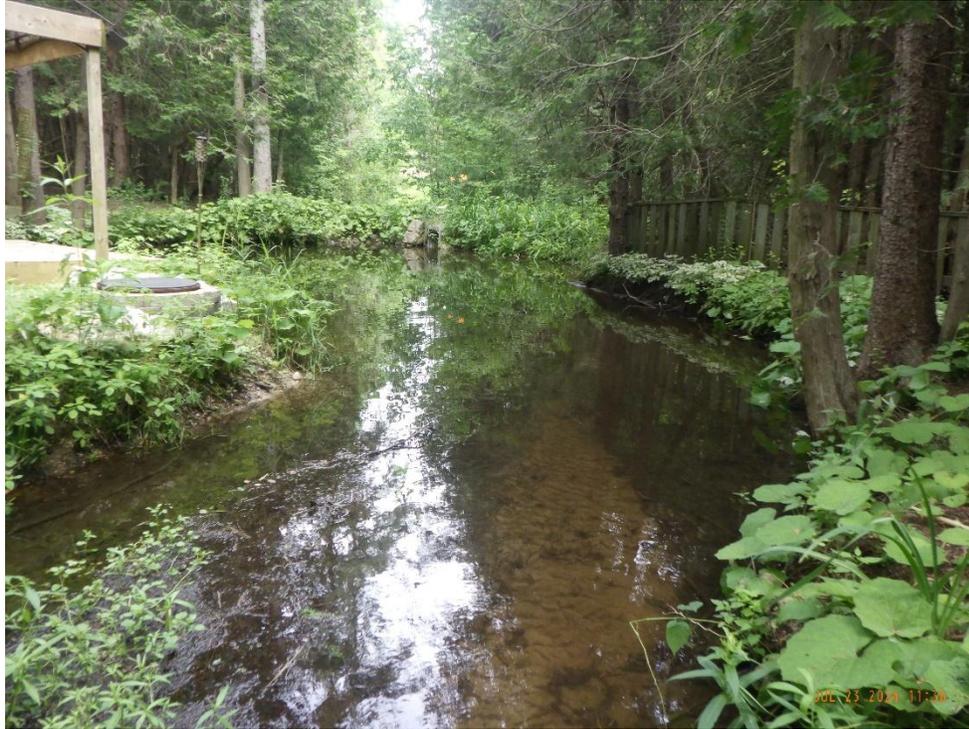
Photo 12
Reach TBR-3, Tributary of Boyne River, Melancthon, Ontario

Photograph taken facing the downstream extent of the reach, ending in an artificial pond. Note the pond drains into a culvert located at the downstream extent of the pond.

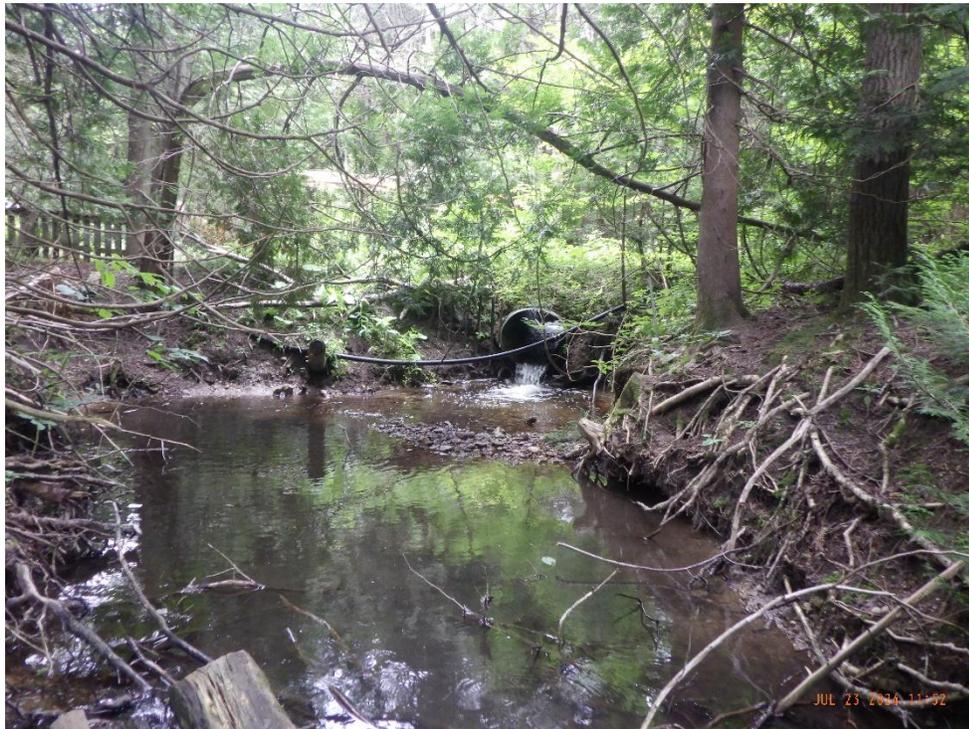
Photo 13
Reach TBR-4, Tributary of Boyne River, Melancthon, Ontario

At the initiation of **Reach TBR-4**, extensive erosion was noted at the CSP outfall. The scour pool measured 0.34 m deep and was bordered by undercut banks (measuring 0.26 m) and exposed roots. From here the reach was relatively straight (i.e., low sinuosity with the occasional, irregular meander) and unconfined. Riparian vegetation became a mature, continuous, cedar forest extending >10 channel widths. No instream vegetation was observed. Average wetted width was 1.59 m, average wetted depth was 0.07 m. The reach primarily showed riffle and run morphology, however, pools, riffles, and runs were all observed and displayed different bed substrate. Grain size for pools was comprised of clay/silt, and sand, riffles were primarily cobbles and runs (non-riffle or pool) ranged from clay/silt to cobble. Banks were made of clay/silt, with angles of 30-60 degrees. 30 to 60% of the bank network showed signs of erosion. Older leaning and fallen trees were frequent throughout the reach, with some instream woody debris present in the channel, however only two woody debris jams were observed (over the span of approximately 180 metres). Some iron staining on bed substrate possibly indicate the presence of groundwater.

Photograph taken at the upstream extent of the **Reach TBR-4**. Note the slightly perched culvert at the pedestrian crossing.

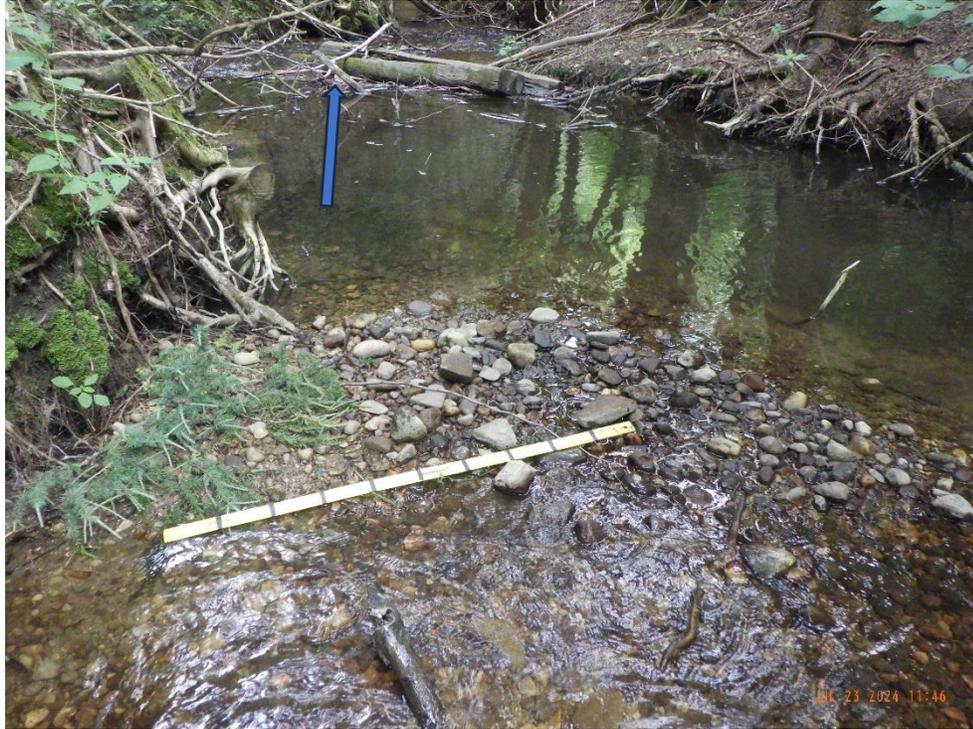
Photo 14

Photograph taken facing downstream. The substrate ranged from silt to small cobbles.

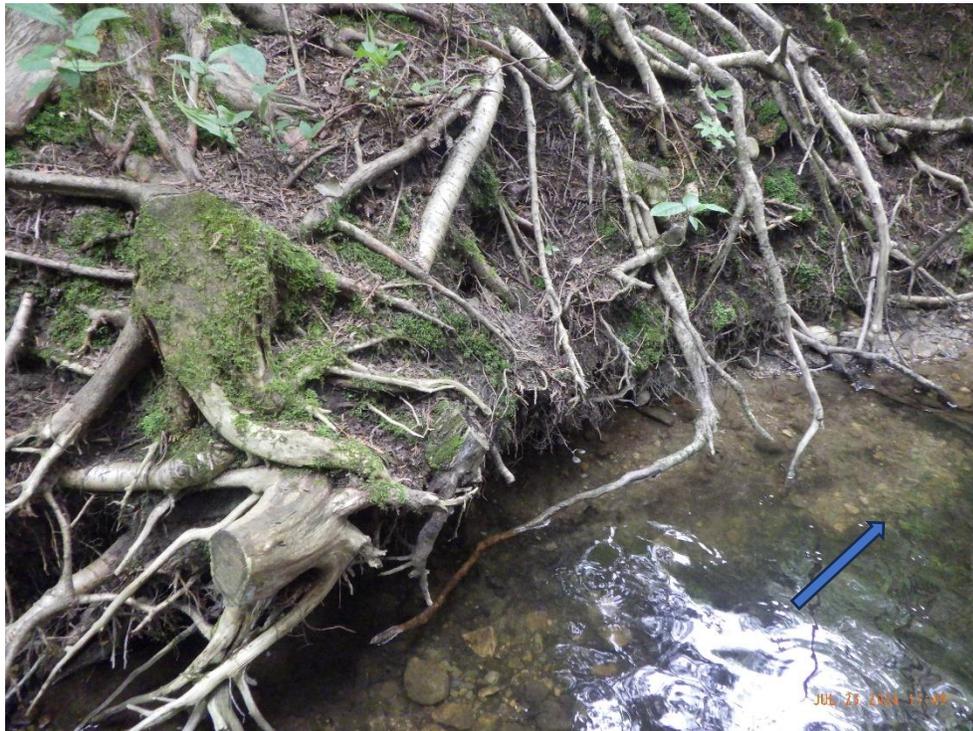
Photo 15

Reach TBR-4 was determined to have an RGA score of 0.381, indicating the reach was in transition with evidence of widening as the dominant process of adjustment. Fallen and leaning trees were noted, along with exposed tree roots, large organic debris, and basal scour along more than 50% of the reach. The RSAT score was 29 for **Reach TBR-4**, indicating the reach was in good health. The limiting feature was channel stability, indicated by fallen trees, exposed roots, highly erodible bottom bank material with areas of unstable banks. The reach was classified as lateral migration based on Downs (1995) classification and exhibited a straight river style framework.

Photograph taken of the left bank, showing exposed tree roots and undercutting. The undercuts in this channel were 0.19 m on average.

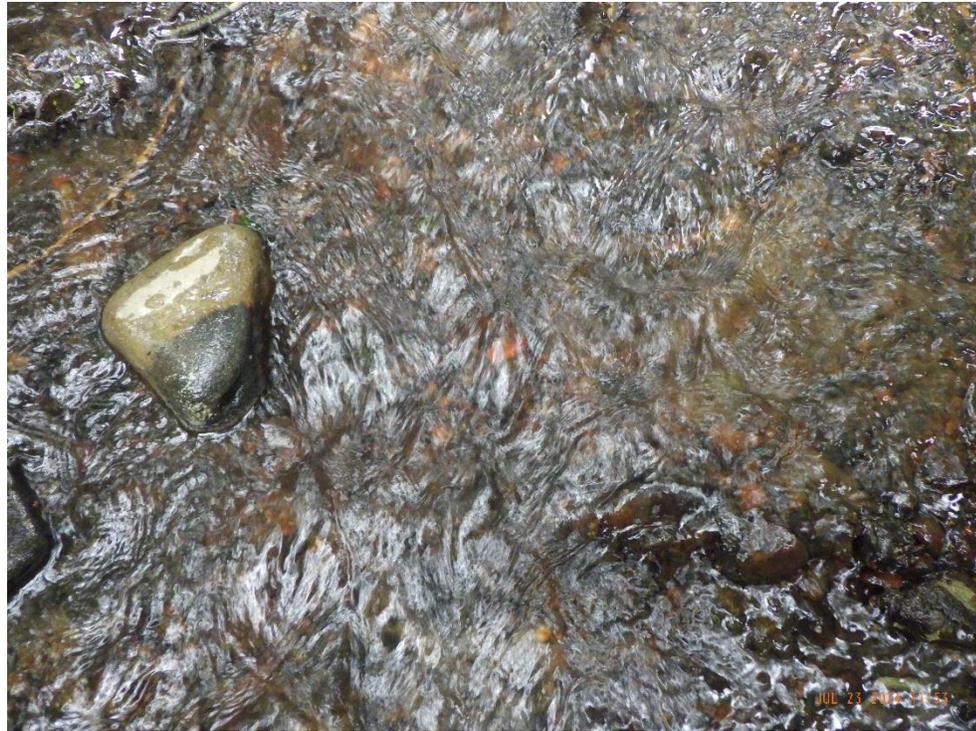
Photo 16

Photograph showing iron staining on the cobble. Evidence of groundwater.

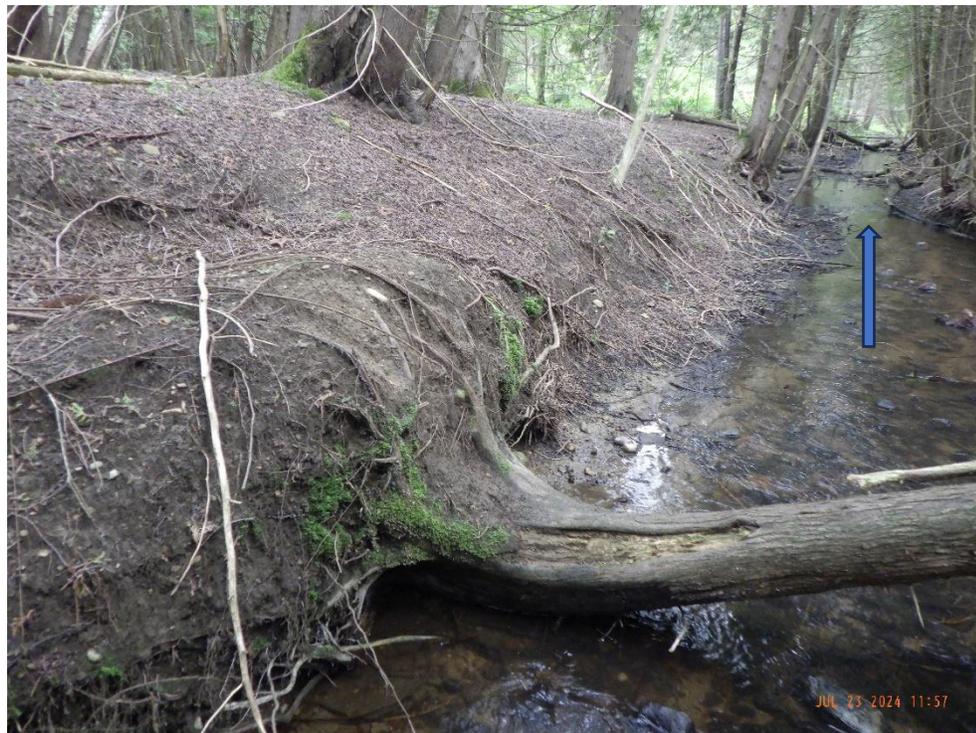
Photo 17

Photograph taken facing downstream of a fallen tree in the channel.

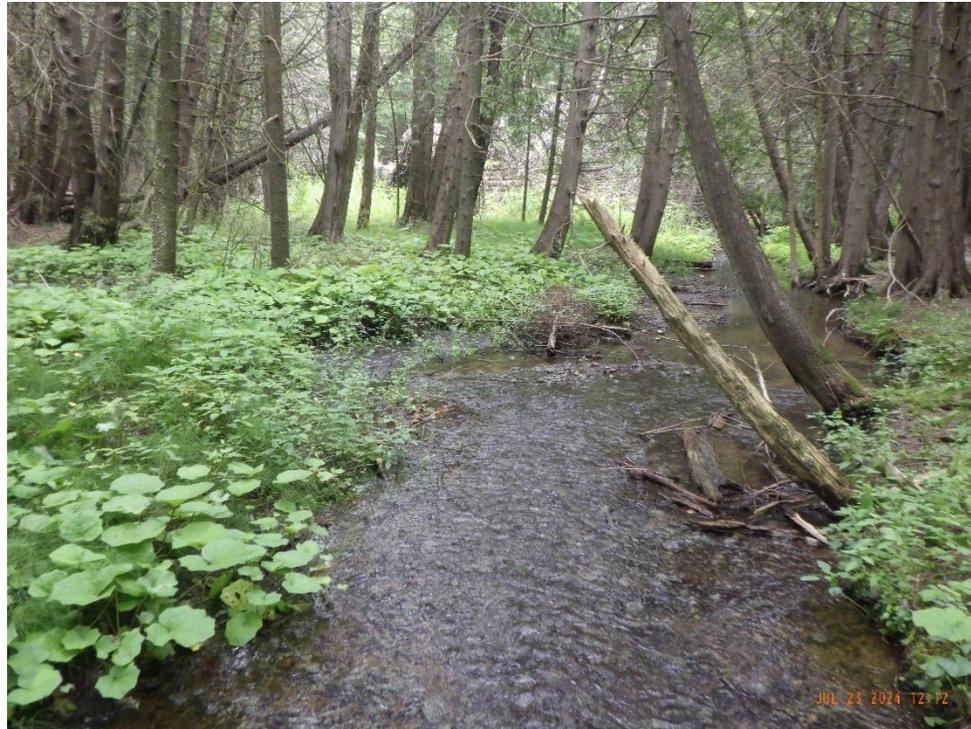
Photo 18
Reach TBR-4, Tributary of Boyne River, Melancthon, Ontario

Photograph facing downstream, showing a riffle. The riffle length was 12.15m.

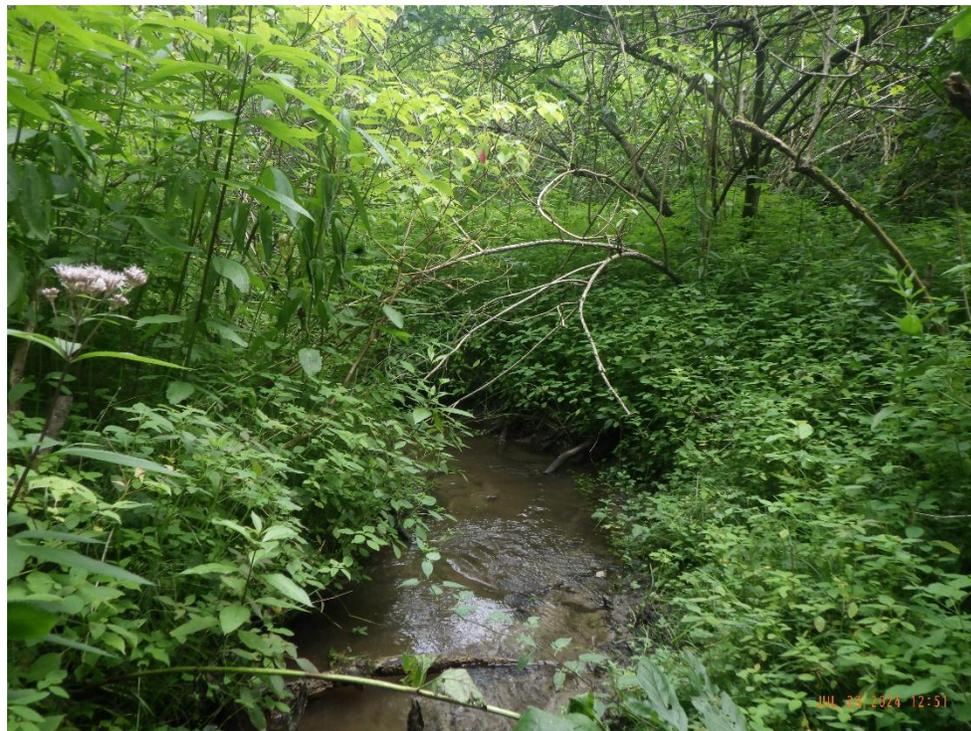
Photo 19
Reach TBR-5, Tributary of Boyne River, Melancthon, Ontario

Photograph taken facing downstream at the upstream extent of **Reach TBR-5**. The vegetation changes from primarily established trees to herbaceous plants.

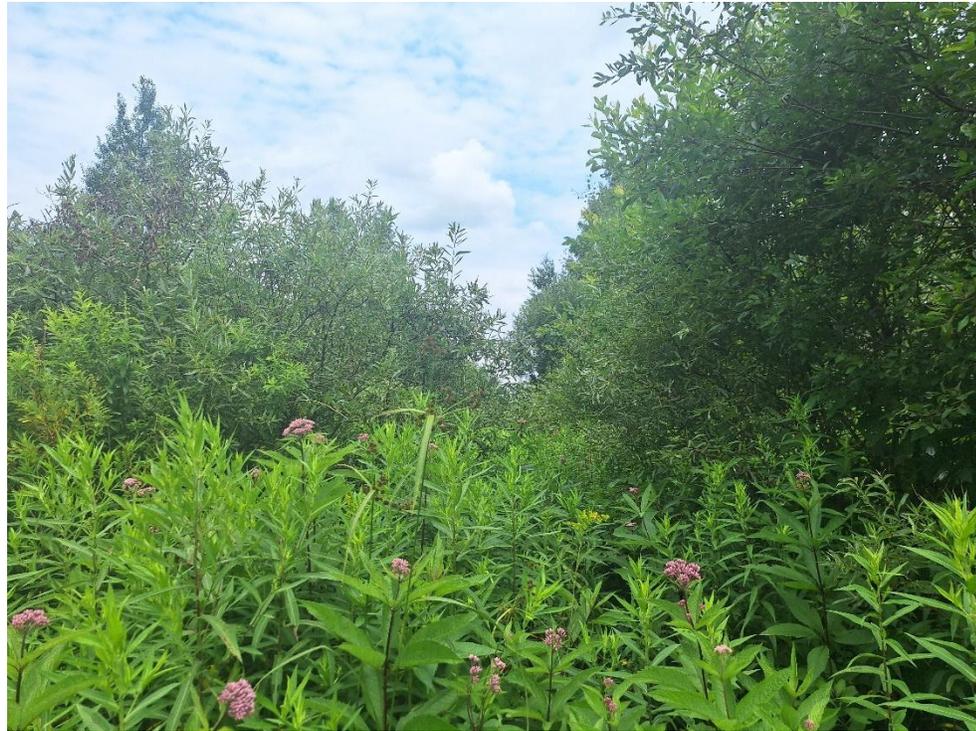
Photo 20
Reach TBR-5, Tributary of Boyne River, Melancthon, Ontario

Photograph showing the open canopy and change in riparian vegetation along reach.

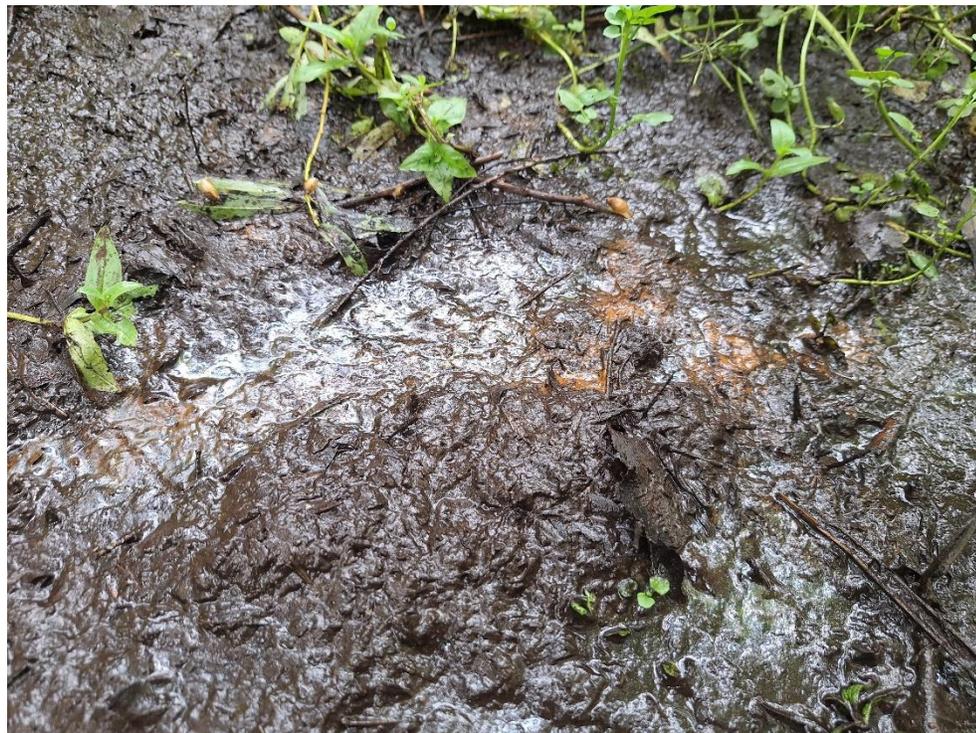
Photo 21
Reach TBR-5, Tributary of Boyne River, Melancthon, Ontario

Photograph showing evidence of groundwater. Iron staining is visible.

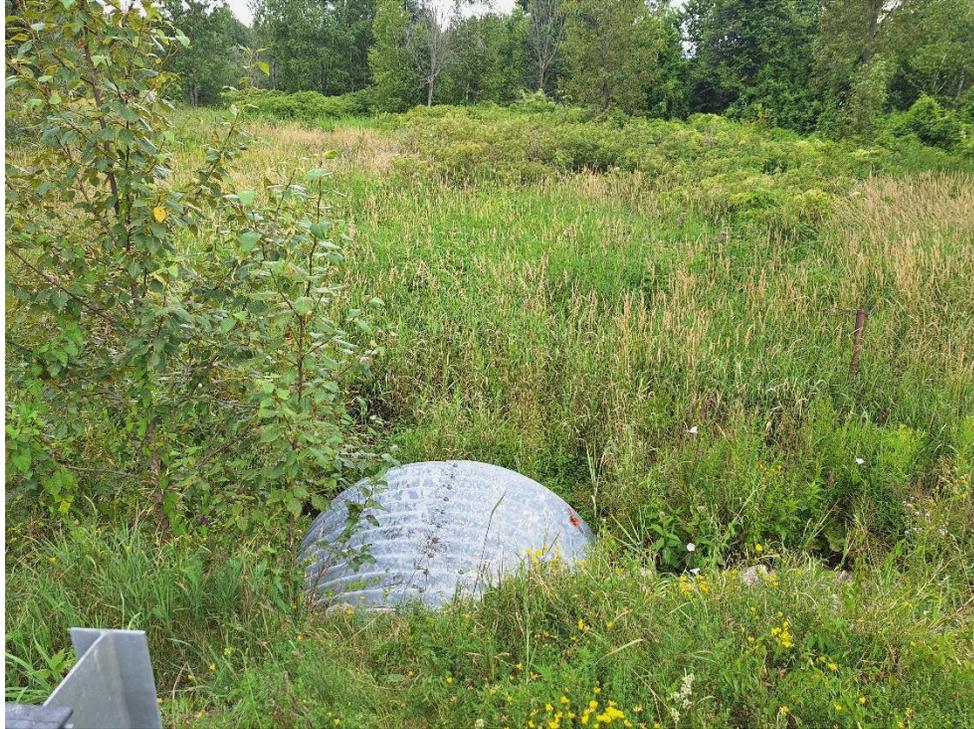
Photo 22
Reach TBR-5, Tributary of Boyne River, Melancthon, Ontario

Photograph taken of the culvert at the downstream extent, facing upstream toward subject property.
