DESKTOP HYDROGEOLOGICAL ASSESSMENT REPORT

SCHEDULE C MUNICIPAL CLASS ENVIRONMENTAL ASSESSMENT DUFFERIN COUNTY ROAD 109 / 2ND LINE REALIGNMENT

NOVEMBER 08, 2023

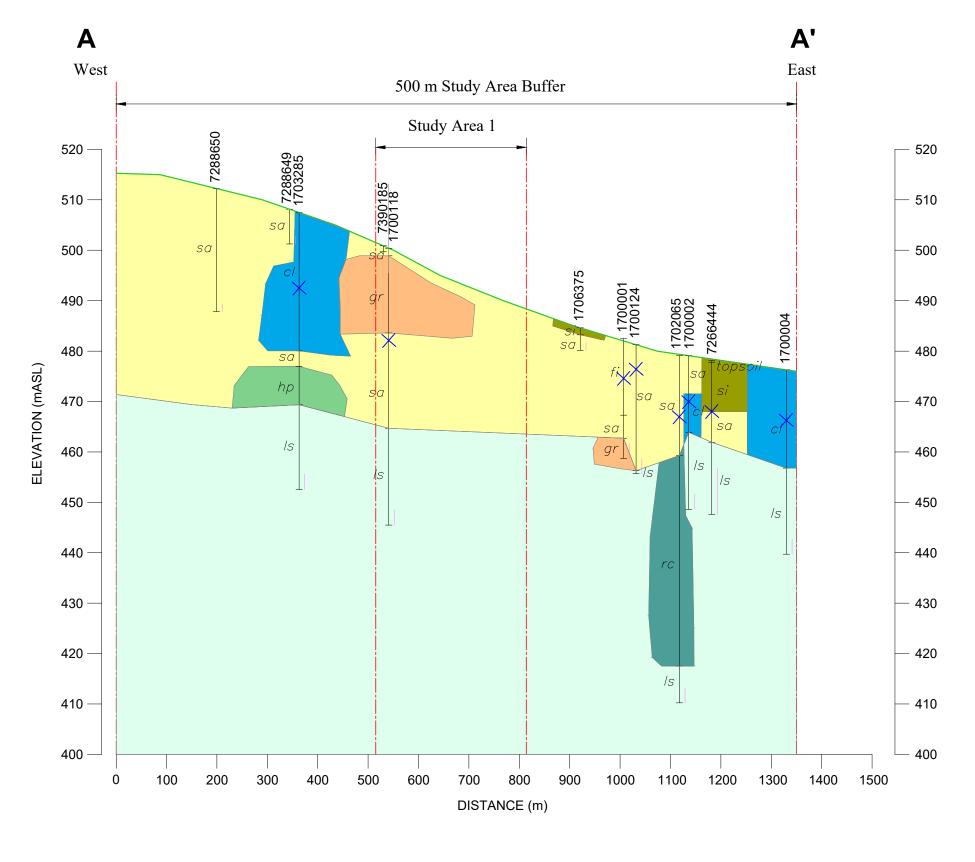
In cross section A-A', the general subsurface conditions consist of a sandy material extending to approximately 35 metres below ground surface (mbgs) in the west and clay material extending to approximately 19 mbgs in the east. Isolated layers of clay, gravel, silt, and hardpan exist throughout the Study Area. Beneath the sand and clay layers is a limestone bedrock. The sands are expected to behave as aquifers. According to the MECP WWRs, static water levels within the Study Area range from approximately 15-18 mbgs in the west to 5-12 mbgs in the east.

In cross section B-B', the general subsurface conditions consist of a sandy or clay material extending to approximately 60 mbgs in the west and approximately 19 mbgs in the east. Isolated layers of clay, gravel, silt, and hardpan exist throughout the Study Area. Beneath the sand and clay layers is a limestone or dolostone bedrock. The surficial sands are expected to behave as unconfined aquifers. According to the MECP WWRs, static water levels within the Study Area range from approximately 32-33 mbgs in the northwest to 12-24 mbgs in the southeast. The static water levels also indicate that two overburden wells are present within the southeast portion of the Study Area that are identified as Municipal water supply wells in the database. The static water levels for these two wells are reported as 1.2 mbgs and 4.2 mbgs. However, the lithologic data is not present in the WWRs for these two wells.

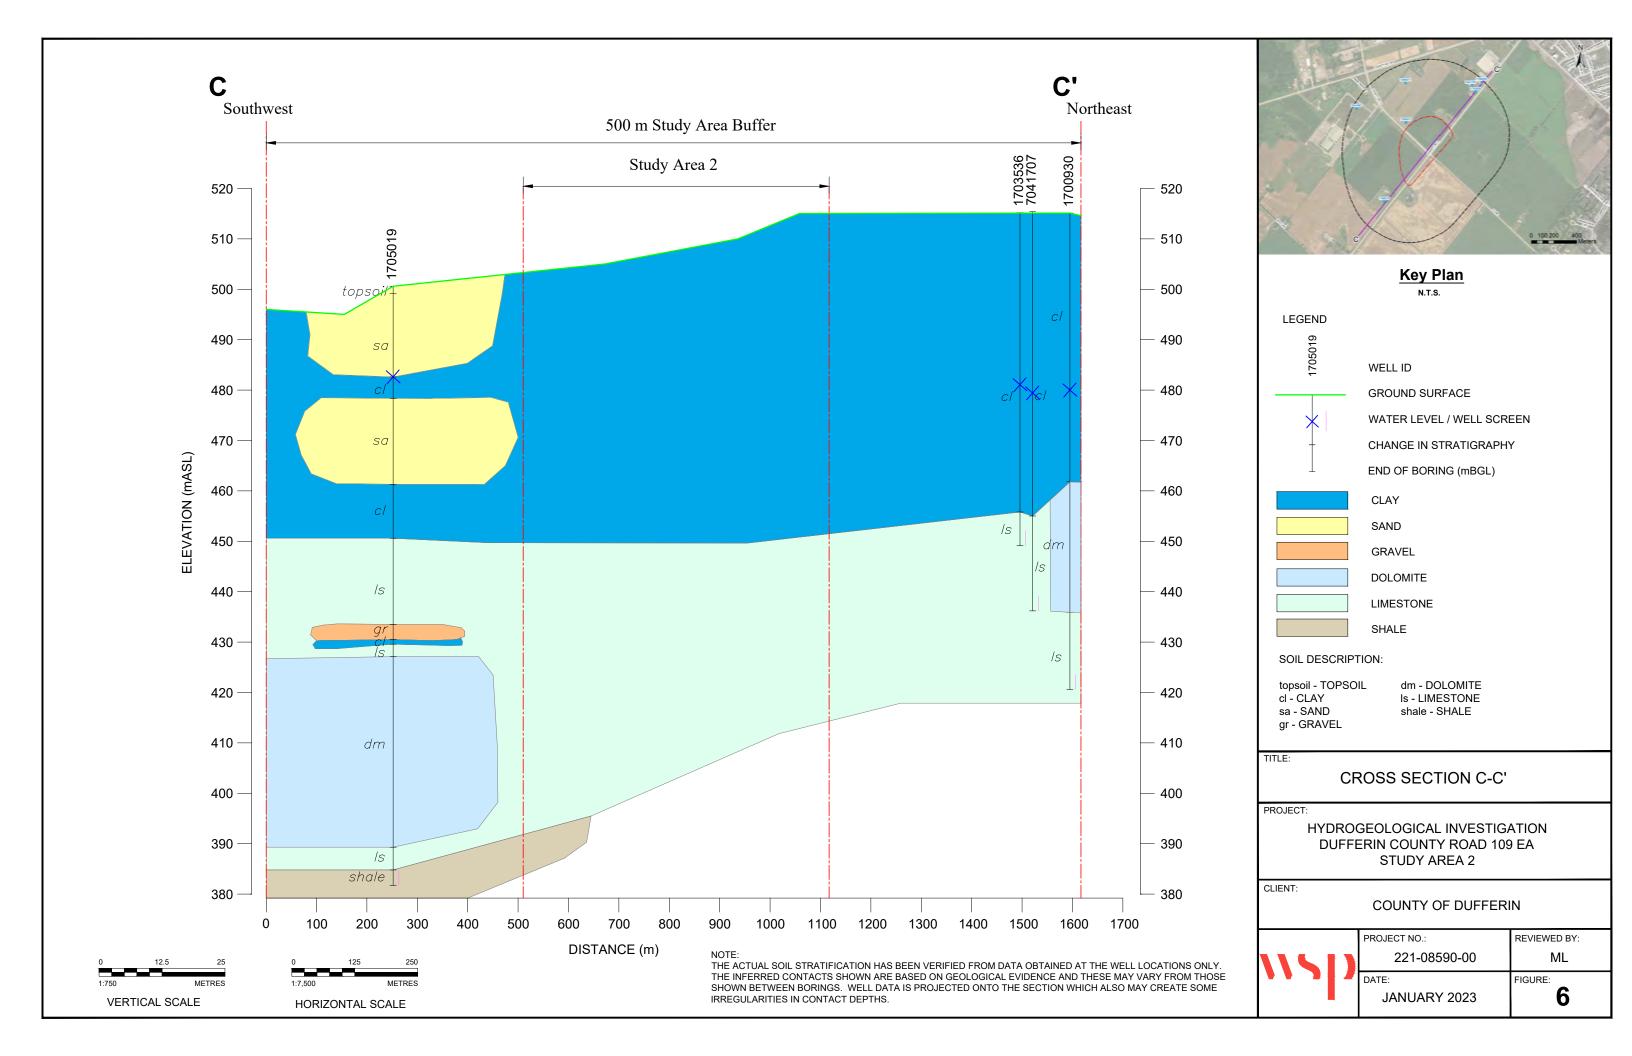
The geologic cross section C-C' (southwest to northeast along County Road 3) for Study Area 2 is presented in Figure 6. The general subsurface conditions consist of a clay material extending approximately 55-65 mbgs. Isolated layers of sand exist in the southwest portion of the Study Area between 4-19 mbgs and 27-39 mbgs. Beneath the clay layer is bedrock consisting of limestone or dolostone bedrock (noted in the well records as dolomite). Shale bedrock was encountered beneath the limestone and dolostone in the southwest portion of the Study Area at approximately 118 mbgs. The areas of clay are expected to behave as aquitards, whereas areas of sand are expected to behave as aquifers. Limestones and dolostones in the area are aquifers that have been targeted by private supply wells. According to the MECP WWRs, static water levels within the Study Area range from approximately 18 mbgs in the southwest to 34-36 mbgs in the northeast.

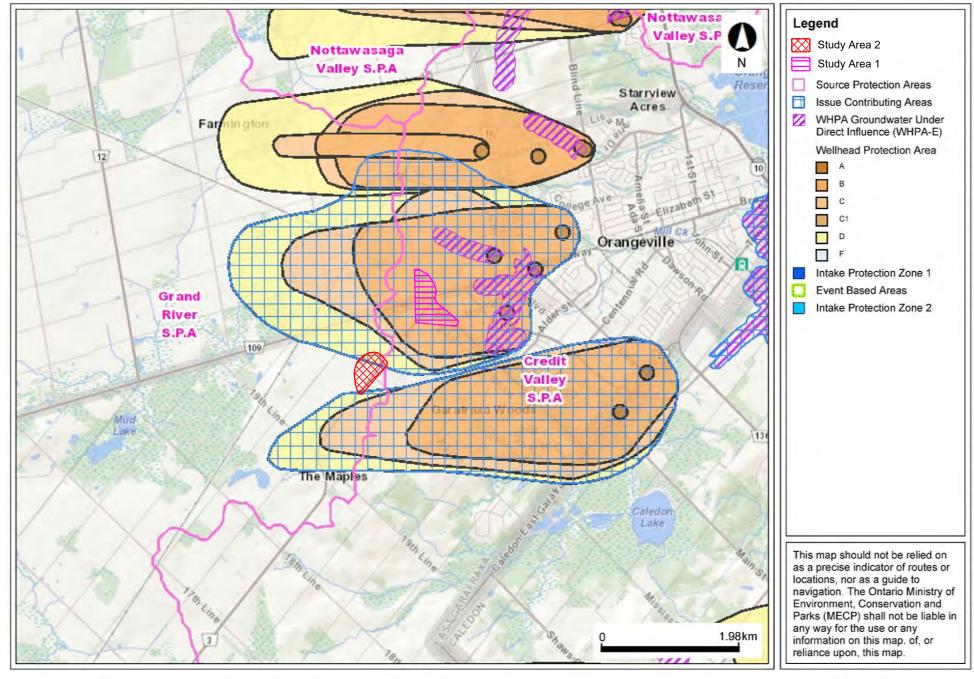
IDENTIFICATION OF VULNERABLE AREAS: STUDY AREA 1 AND STUDY AREA 2

Source Protection Vulnerability

- WSP recommends implementing an ESC plan for any groundwater receptors in the Study Areas. Both Study Areas are located in a SGRA, and Study Area 1 is located within HVA. ESC best practices should be applied during the construction, clean-up, and restoration to prevent sediment-laden runoff from entering any known precipitation recharge area.
