Fluvial Geomorphology Assessment and Meander Belt Width Delineation

Tributary of Boyne River
Melancthon, Ontario

Submitted:
August 21, 2025

GEO Morphix Project No. 24060

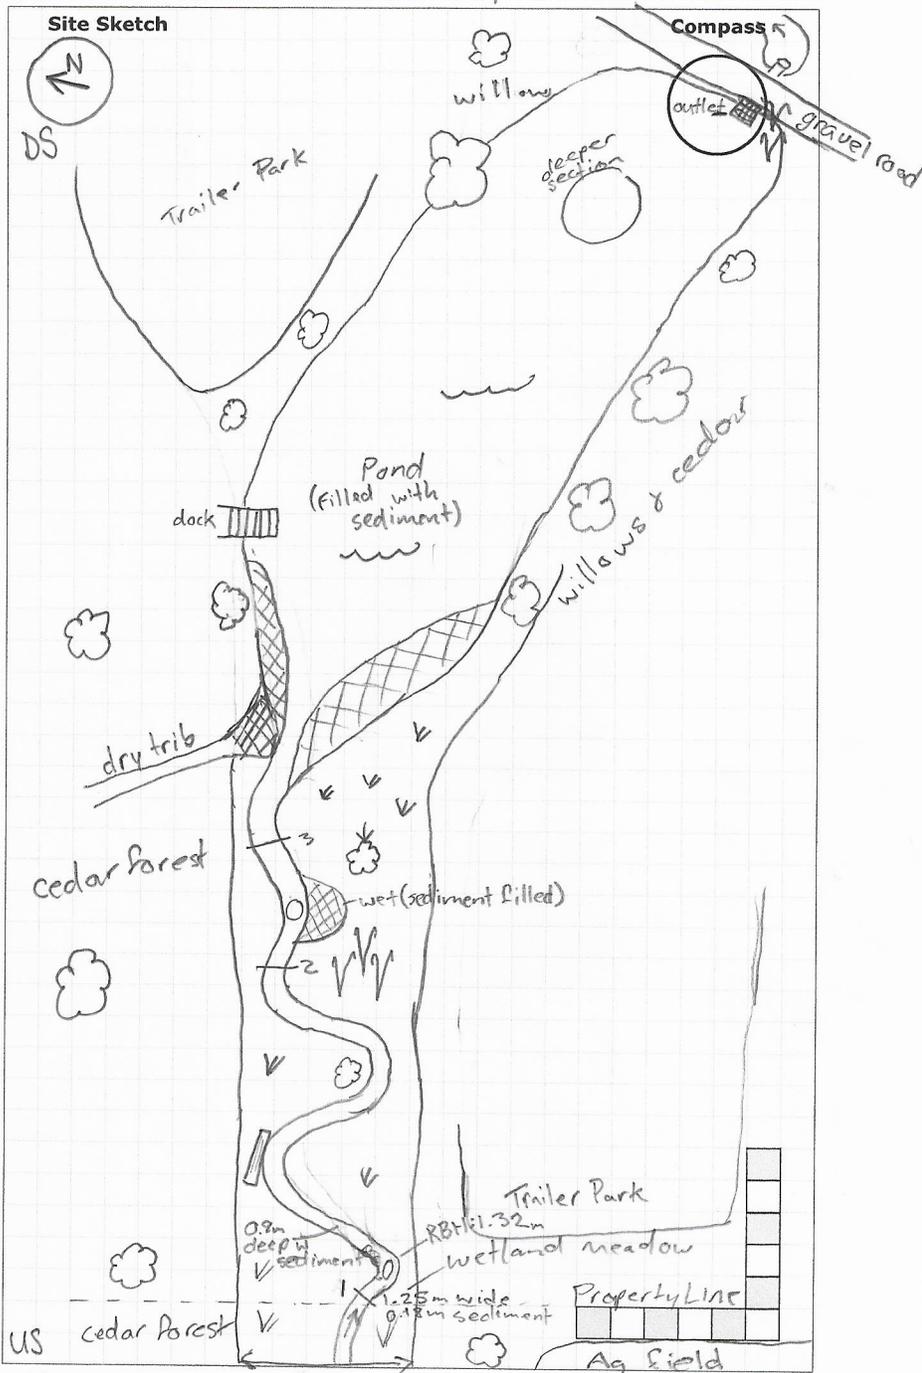
Photos: _____
Notes: US

Substrate: fines. Outlet of pond is metal box grate that is partially blocked/clogged with vegetation, causing a large change in water level elevation DS of the road.

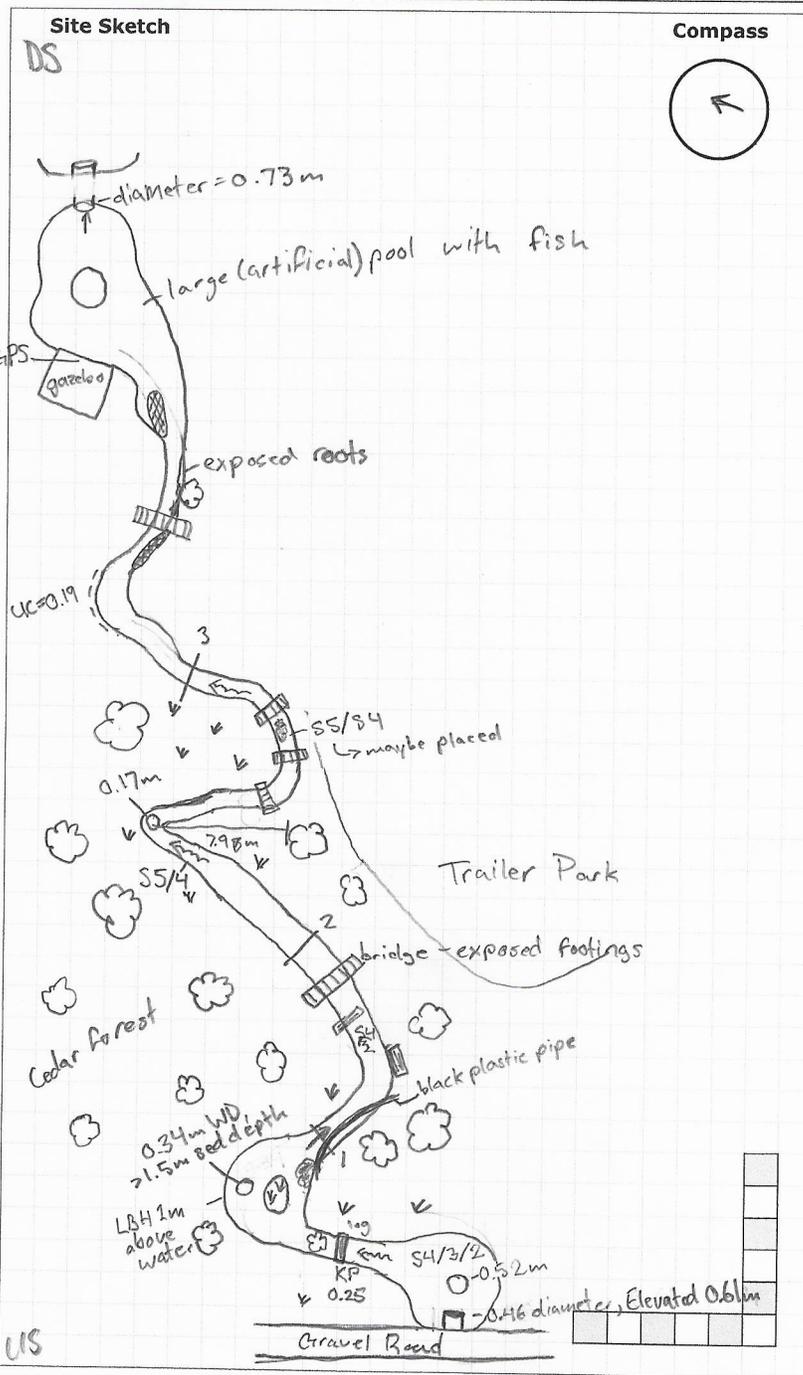
Photos: _____
 Notes: GPS pt 009 @ pool w gazebo

Sand, gravel, small cobbles as bed material.
 Loamy soil as banks (sand + clay + organics)

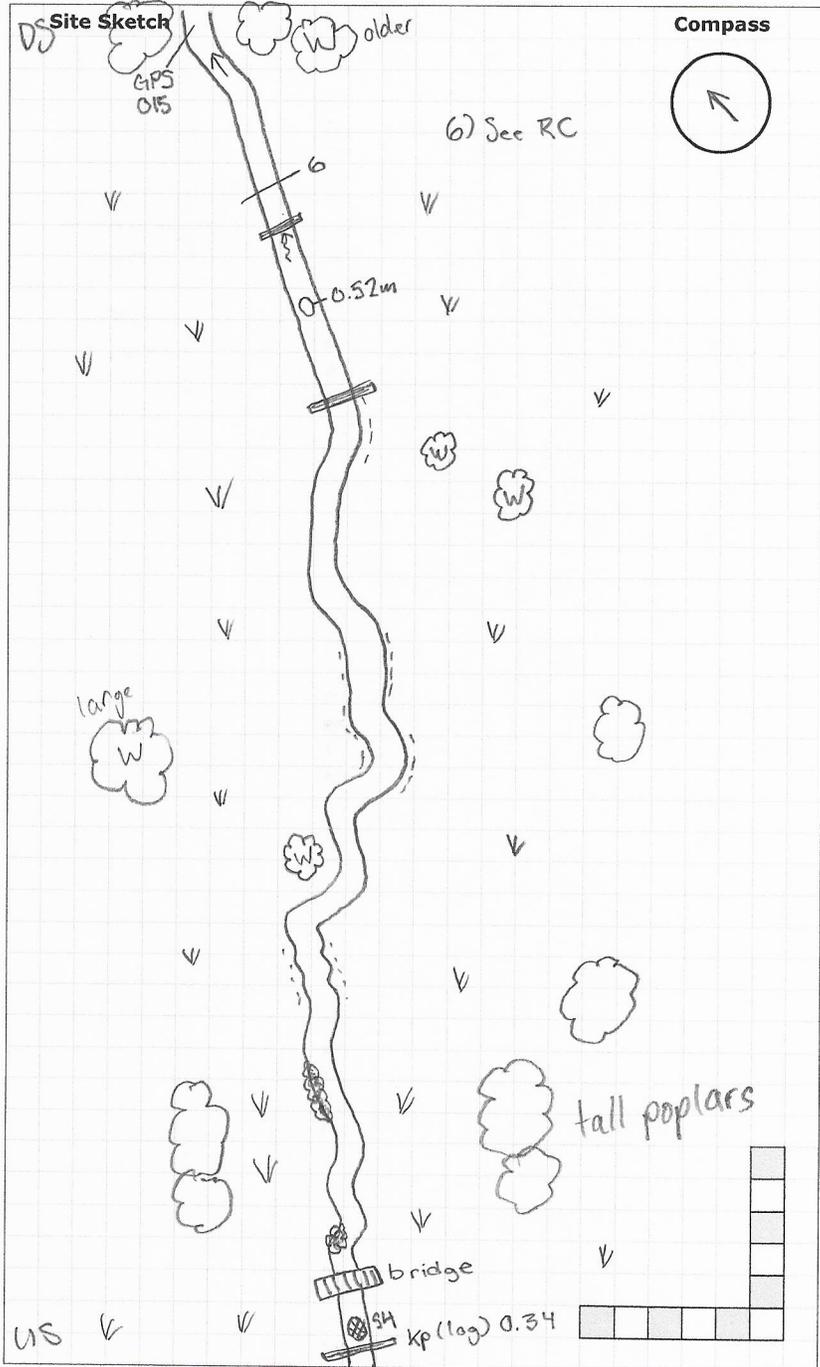
Notes: @DS channel entered a stand of older

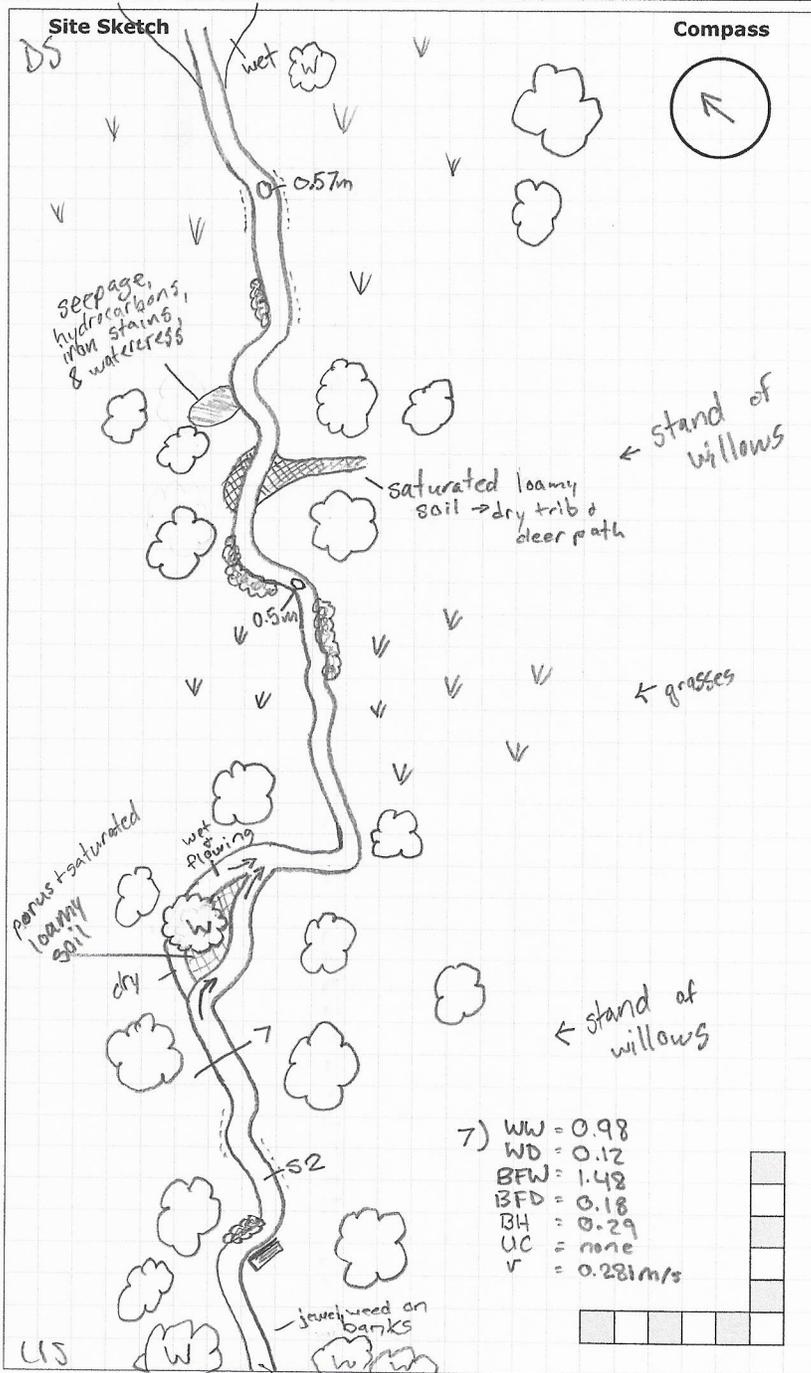
Notes: Channel gets deeper in DS section.

Undercutting common, narrow channel. Loamy organics in banks. Sand + organics bed

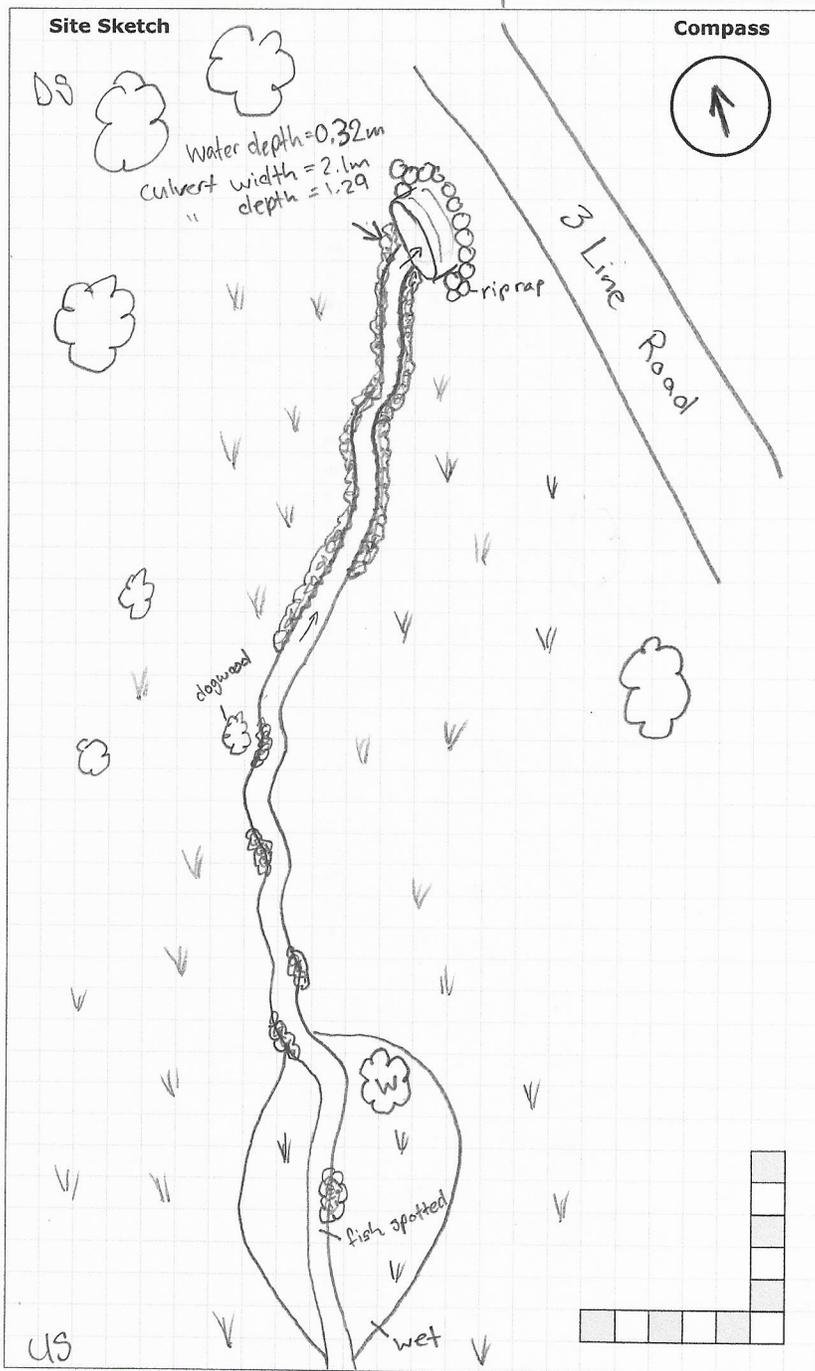
Notes: Watercress increased. Channel narrow with frequent undercutting. Sand build up in culvert. (see photos)
